INACTIVE AND ABANDONED MINE LANDS— Van Stone mine, Northport Mining District, Stevens County, Washington

by Fritz E. Wolff,
Donald T. McKay, Jr.,
and David K. Norman

WASHINGTON
DIVISION OF GEOLOGY
AND EARTH RESOURCES
Information Circular 100
December 2005

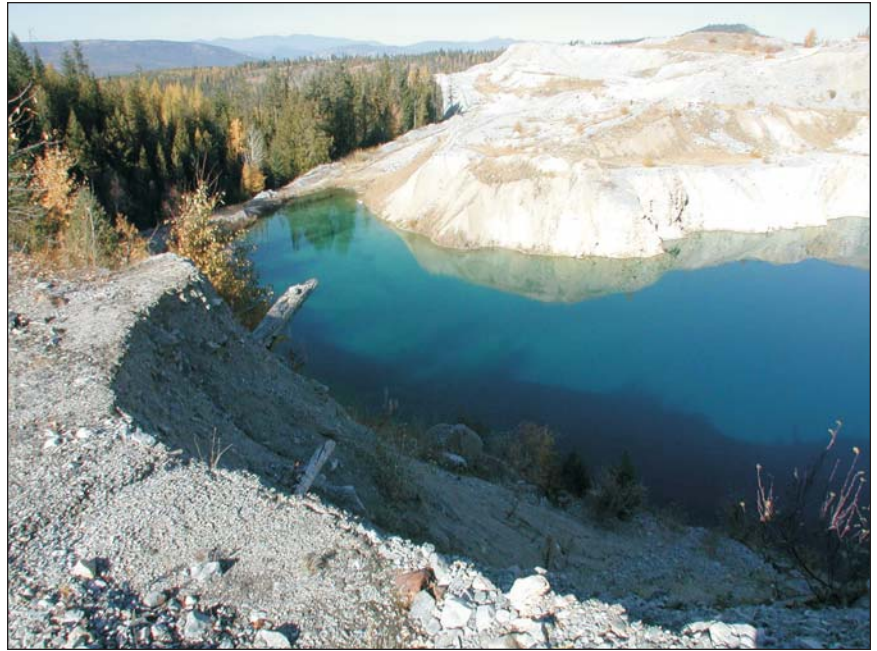
Figure 4. West End pit lake. Note glacial alluvium slope in foreground. View to the northwest.

The West End pit is 700 feet long and 700 feet wide, including pit walls. With the exception of an unexcavated blast at a bench on the north side of the lake, all the mining done by Equinox was below the current water level at elevation 3510 down to elevation 3400 (Randy Miller, caretaker, written commun., 2003). The south bank of the lake is a steep and badly eroding exposure of glacial alluvium.

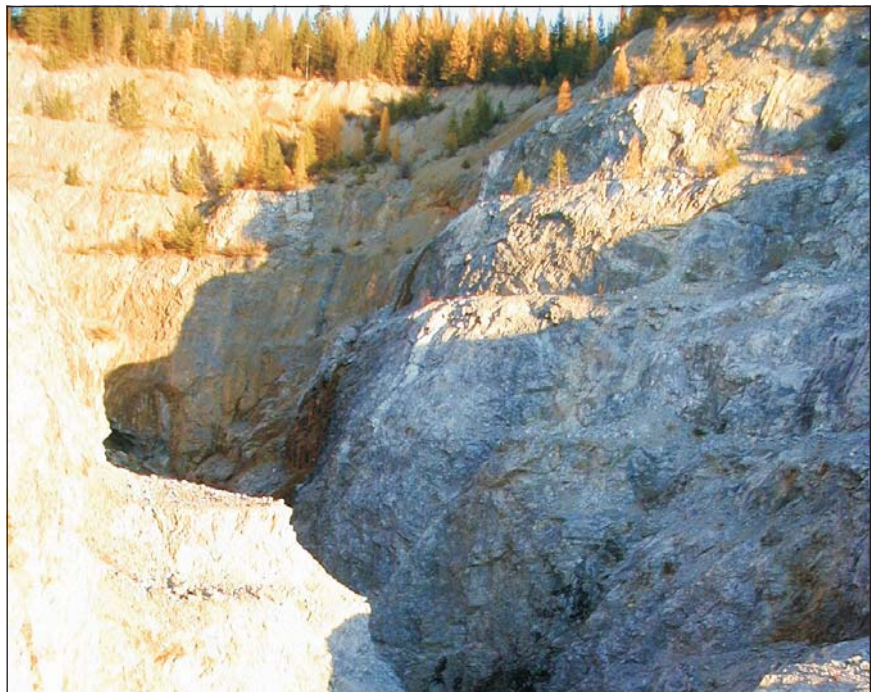
Figure 5. North pit. View to the east.

The North pit (Figs. 3–5) is a composite of two different operations separated in time, but contiguous geographically. We refer to the area mined initially by Asarco as the North pit high-wall and the area mined by Equinox as the West End pit. The North pit highwall excavation is 400 feet wide rim-to-rim and approximately 1000 feet long. Its longitudinal axis strikes N80E. The floor is littered with boulders and scree. The pit walls show significant structural cracks and signs of failure. The difference between the highest rim elevation and the pit floor is approximately 430 feet. The area is inaccessible except by helicopter or boat because the benches transition into cliff bands and the West End pit lake prohibits land access at the pit floor.

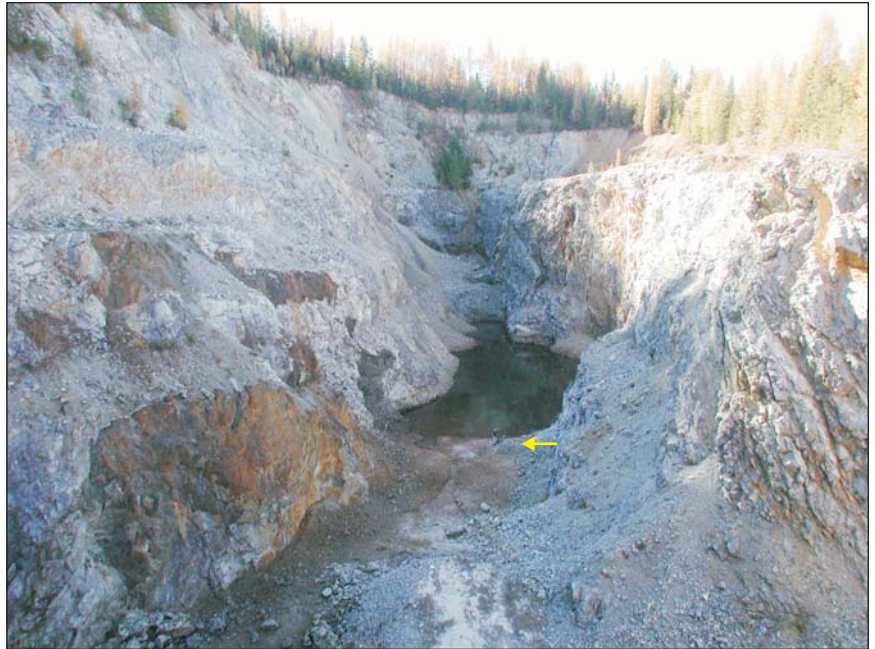
Figure 6. South pit. Geologist for scale (arrow). View to the south.

the West End outlet dam and approximately 1000 feet south. It resembles a box canyon in that the entry and exit points are through a narrow cut in the northwest corner. Maximum elevation difference from rim to floor is 180 feet. Snowmelt and precipitation have created a lake 2 to 3 feet deep in the center.

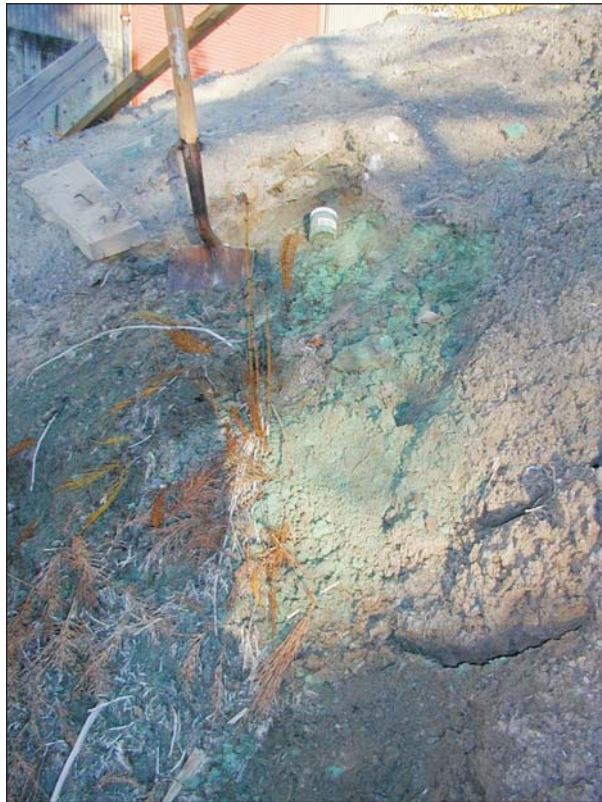
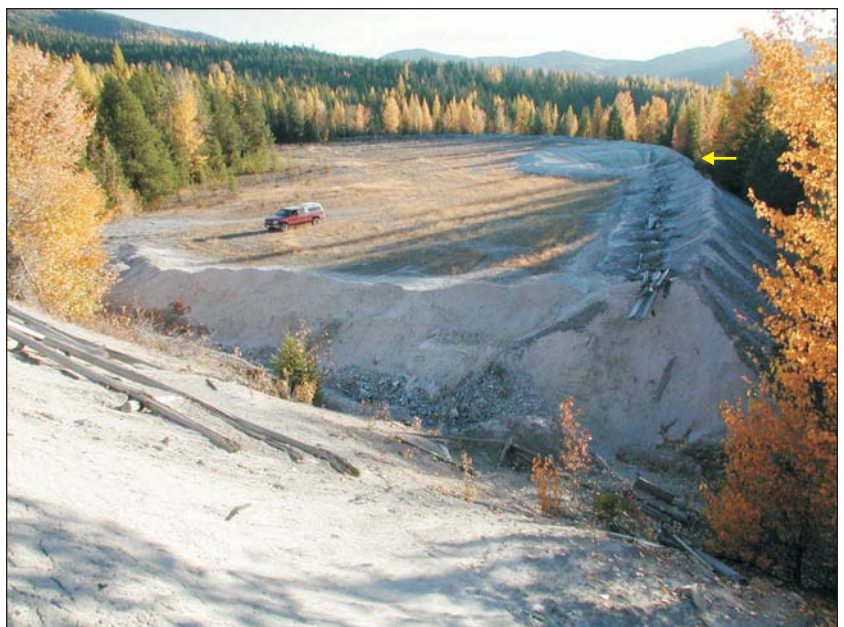
Figure 22. (middle) Upper tailings pond, point of 1961 berm failure in west basin. View to the northwest.

In April 1961, the dam at the western extreme end of the west basin failed (Fig. 22), sending a wall of water down Onion Creek. The flood widened Onion Creek by 20 to 30 feet and created a debris dam that plugged a culvert at the county road and eventually failed. Oddly, we found little evidence of erosion or rilling downslope from the breach. The channel supports a vigorous stand of pine and fir. It appears Asarco abandoned this disposal area soon after the accidental discharge in favor of an 80-acre site in secs. 29 and 30, approximately 2 miles to the northwest. Some revegetation has taken place on the west basin. Equinox installed an 8-inch ABS tailings discharge line to the Upper site in case of failure at the Lower repository. This line, which was never used (Miller, written commun., 2002), can be seen emerging from the forest near the south end of the berm separating the two basins.

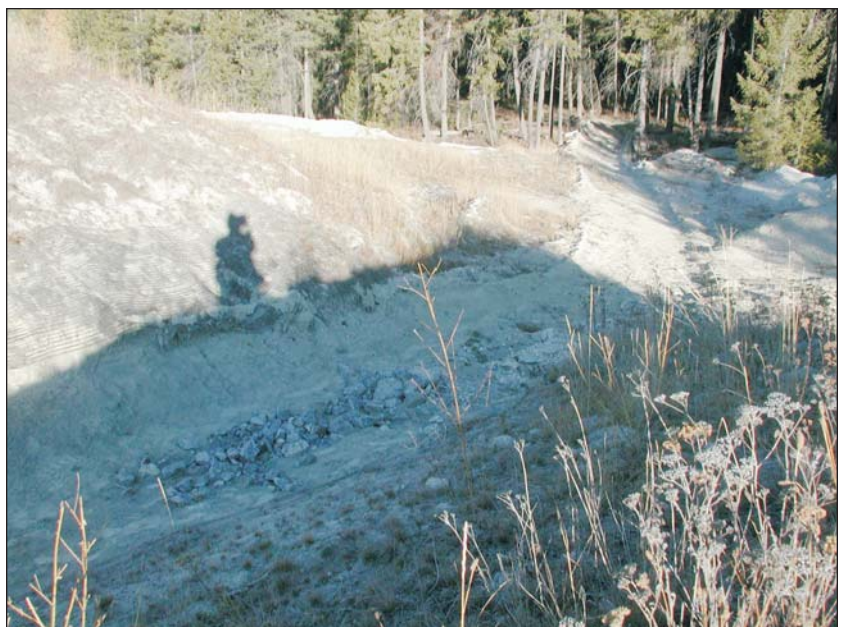
Figure 26. (bottom) Rilling and erosion at the north-west corner of the Lower tailings pond. View to the southwest taken October 2002.

rushes and grass covering about 10 percent of the total surface (Fig. 24). Eight-inch cement-asbestos pipe and wood-stave pipe from the Asarco era lie on the surface in various places. Stacks of black ABS flexible tailings line and 6-inch steel water-return line from the Equinox era are also located at numerous points. According to caretaker Randy Miller (written commun., 2003) all of the tailings produced by Equinox were discharged at the lower site. The height of the impoundment dam varies from 30 feet at the northeast corner to 90 and 100 feet respectively on the south and west extremities. Two lifts are present, separated by a 30-foot-wide bench (Fig. 25). The edges of the berm are rilled with holes, cracks, gullies, and it is piping in places. A chain link fence is intact on parts of the perimeter, but collapsed at other points where the berm has slumped (Fig. 26).
