INACTIVE AND ABANDONED MINE LANDS— Van Stone mine, Northport Mining District, Stevens County, Washington

by Fritz E. Wolff,
Donald T. McKay, Jr.,
and David K. Norman

WASHINGTON
DIVISION OF GEOLOGY
AND EARTH RESOURCES
Information Circular 100
December 2005

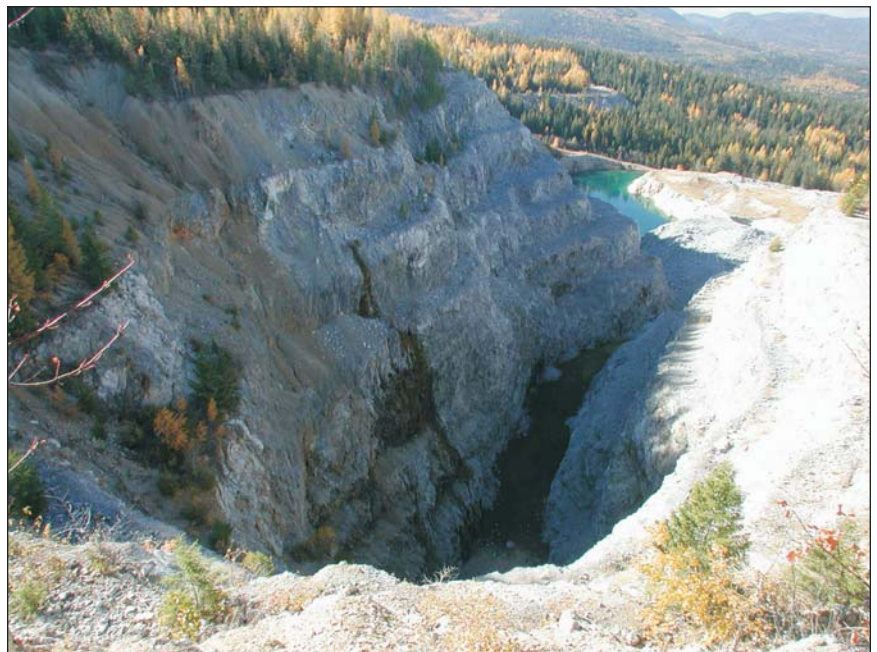
Figure 3. Overview of the North pit (foreground) and West End pit (background) with pit lake. View to the west.

The North pit (Figs. 3–5) is a composite of two different operations separated in time, but contiguous geographically. We refer to the area mined initially by Asarco as the North pit high-wall and the area mined by Equinox as the West End pit. The North pit highwall excavation is 400 feet wide rim-to-rim and approximately 1000 feet long. Its longitudinal axis strikes N80E. The floor is littered with boulders and scree. The pit walls show significant structural cracks and signs of failure. The difference between the highest rim elevation and the pit floor is approximately 430 feet. The area is inaccessible except by helicopter or boat because the benches transition into cliff bands and the West End pit lake prohibits land access at the pit floor.

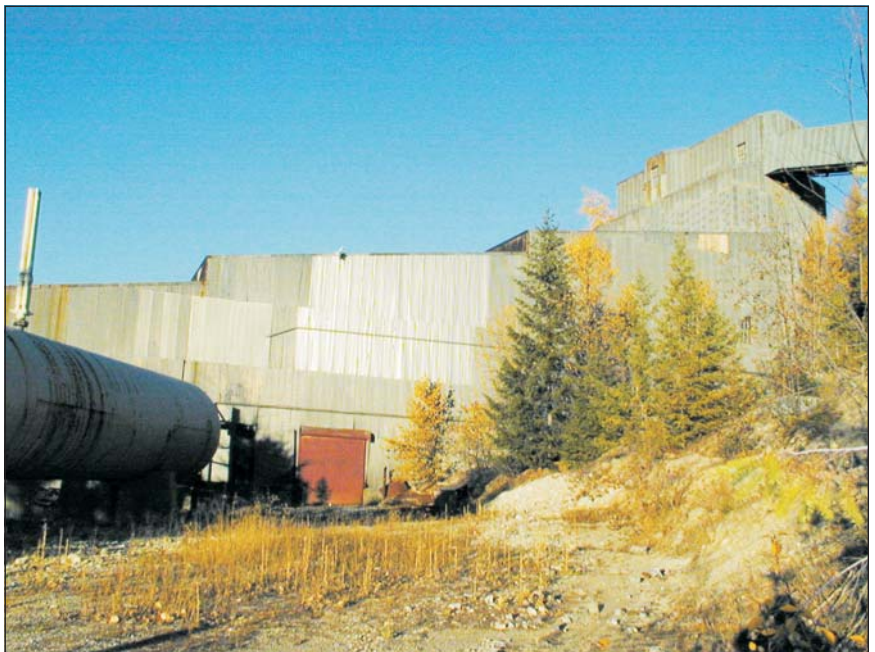
Figure 7. Mill buildings. View to the north.

The mill building and crusher plant are the largest structures on the property (Figs. 7 and 8). Both were in excellent condition in October 2002. A machine shop, warehouse, and receiving shed are located near the north side of the mill. A core-storage shack, assay office, mine office, and scale house are closely spaced along the entry road. A two-ton flatbed truck with hydraulic

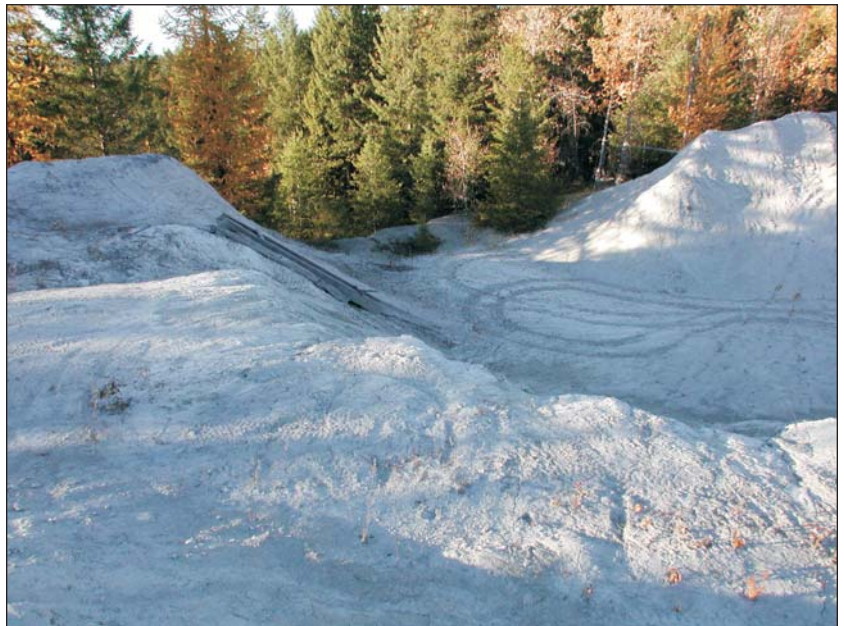
Figure 25. (middle) Bench between lifts at Lower tailings pond. View to the west taken October 2002.

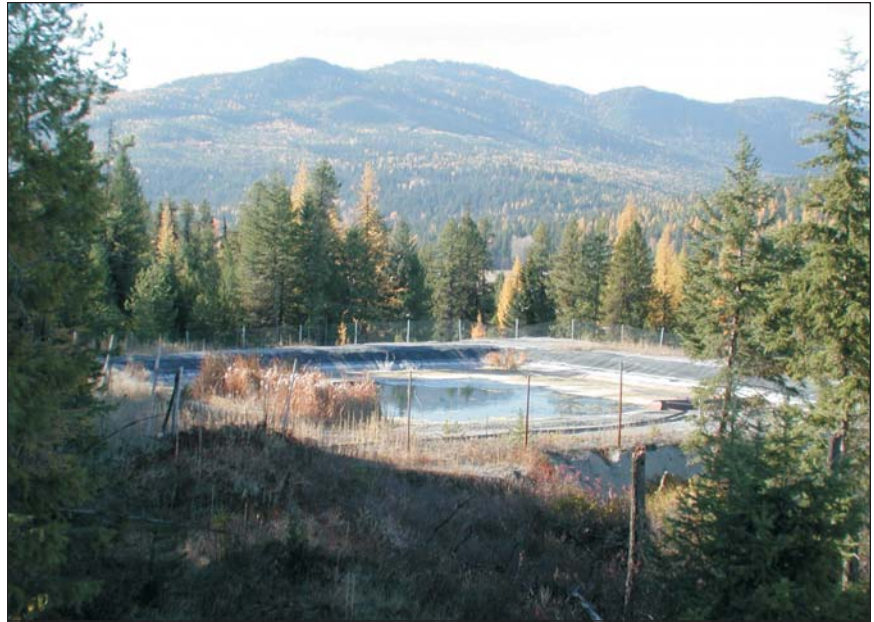
Equinox constructed an approximately 1-acre waste-water retention pond near the southeast corner of the Lower pond, but Miller (written commun., 2003) stated that it was never put in use. It is fenced and contains a small amount of standing water and thick algae (Fig. 27).

Figure 27. Waste-water retention facility near the Lower tailings pond. View to the southwest.
